SUZUKI MOTOR OF AMERICA, INC.

IMPORTANT SAFETY RECALL

July 17, 2015

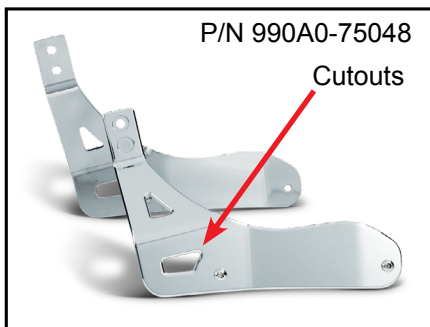
If the motorcycle is equipped with early model backrest mounting brackets with cutouts as shown below, no action is needed.

Early Model Brackets
NO REPAIR NEEDED
Because it is equipped with two 75mm and two 95mm mounting bolts.

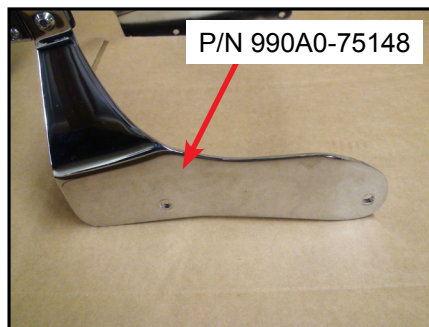
The mounting hardware for installing the Suzuki Genuine Accessory backrest P/N 990A0-75148 and P/N 990A0-75148-BLK on 2006 - 2015 Suzuki VZR1800 (Boulevard M109R) motorcycles may contain 110mm mounting bolts, which is an incorrect length. Under certain loads and riding conditions, it may be possible for the mounting bolts to contact the rear tire, damaging it and/or causing loss of control, increasing the risk of a crash.

If the motorcycle is equipped with late model backrest mounting brackets without cutouts and it does NOT have saddlebag supports, the mounting bolts must be replaced.

Late Model Bracket without saddlebag supports
NEEDS REPAIR
Because it is equipped with incorrect four 110mm mounting bolts — these bolts must be replaced with correct 75mm (two) and 95mm (two) mounting bolts.

If your backrest was installed with the incorrect mounting bolts, your Suzuki dealer will replace them with the correct mounting bolts. This procedure will take approximately 10 minutes to complete. Parts are available now, and there will be no charge to you for any recall service-related parts or labor.

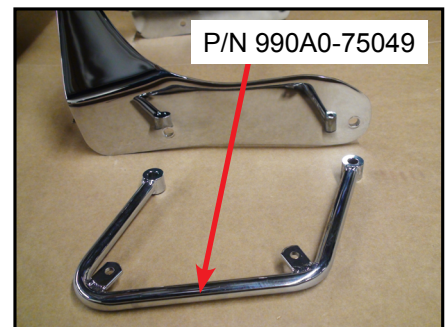
If the motorcycle is equipped with late model backrest mounting brackets without cutouts and it is equipped with Suzuki Genuine saddlebag supports (P/N 990A0-75049), no action is needed.

Late Model Bracket with saddlebag supports
NO REPAIR NEEDED
Because it is equipped with longer four 110mm mounting bolts required for the saddlebag supports. Shorter 75mm (two) and 95mm (two) bolts are not required.
SEE WARNING ON NEXT PAGE.

If the Suzuki Genuine saddlebag supports (P/N 990A0-75049) are removed and the saddlebag support bolts are used to install only the backrest, these bolts are an incorrect length and may come into contact with the rear tire. This may cause the rider to lose control, increasing the risk of a crash.

If the saddlebag supports are removed, the mounting bolts must be replaced using Suzuki bolt kit P/N 990A0-75048-002 or P/N 990A0-75048-003 (black). Please contact an authorized Suzuki dealer before removing the saddlebag supports. Your Suzuki dealer will remove the saddlebag supports and replace the mounting bolts.
